**TRANSPORTATION SCIENCES
CRASH DATA RESEARCH CENTER**

Veridian Engineering
Calspan Operations
Buffalo, New York 14225

**CALSPAN ON-SITE AIR BAG RELATED CHILD FATALITY INVESTIGATION
CALSPAN CASE NO. CA96-010
VEHICLE - 1996 DODGE CARAVAN SE
LOCATION - TENNESSEE
CRASH DATE - 1996**

Contract No. DTNH22-94-07058

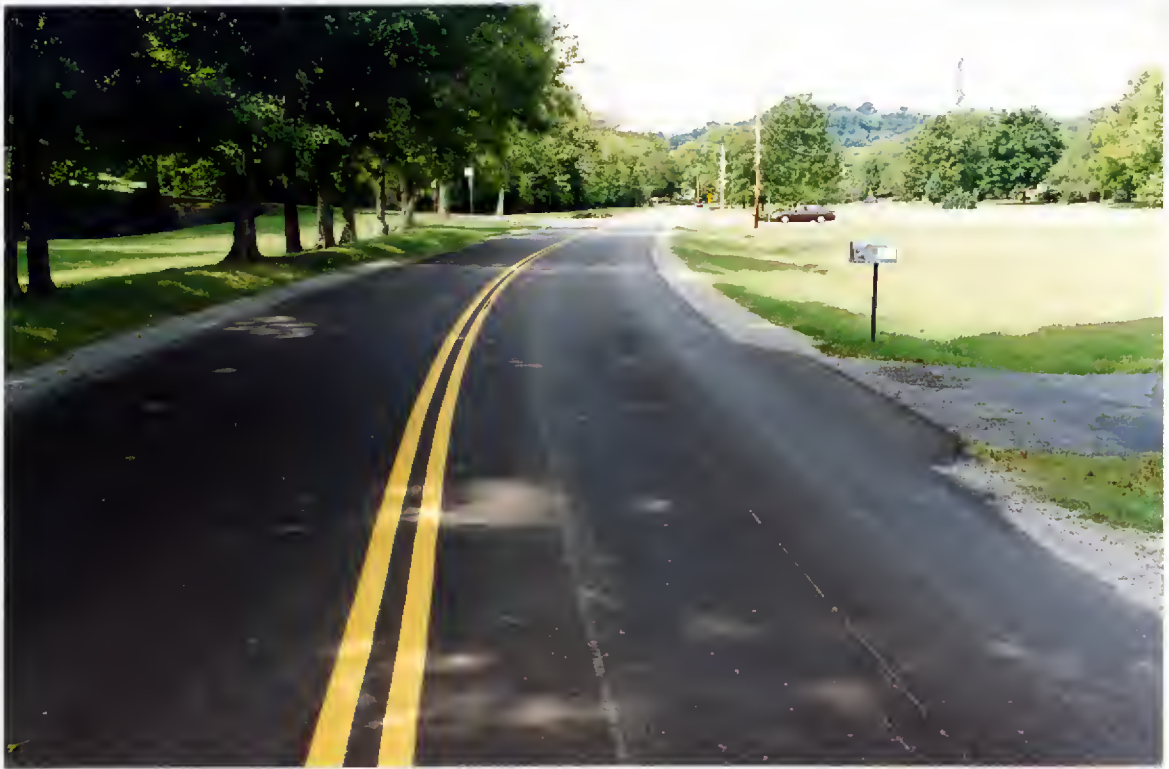
1. Northbound view of the Dodge Caravan's initial approach to the crash scene.

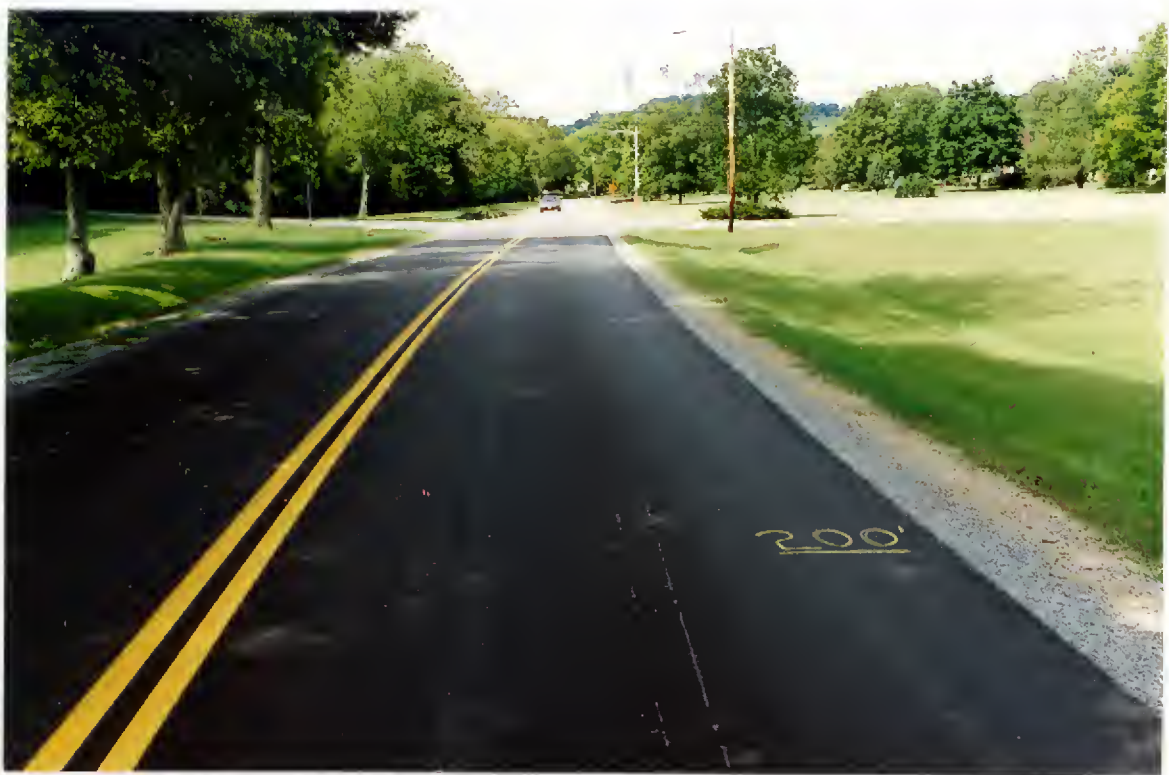
2. Dodge Caravan's approach view at 61 meters (200 feet) from point of impact (POI).

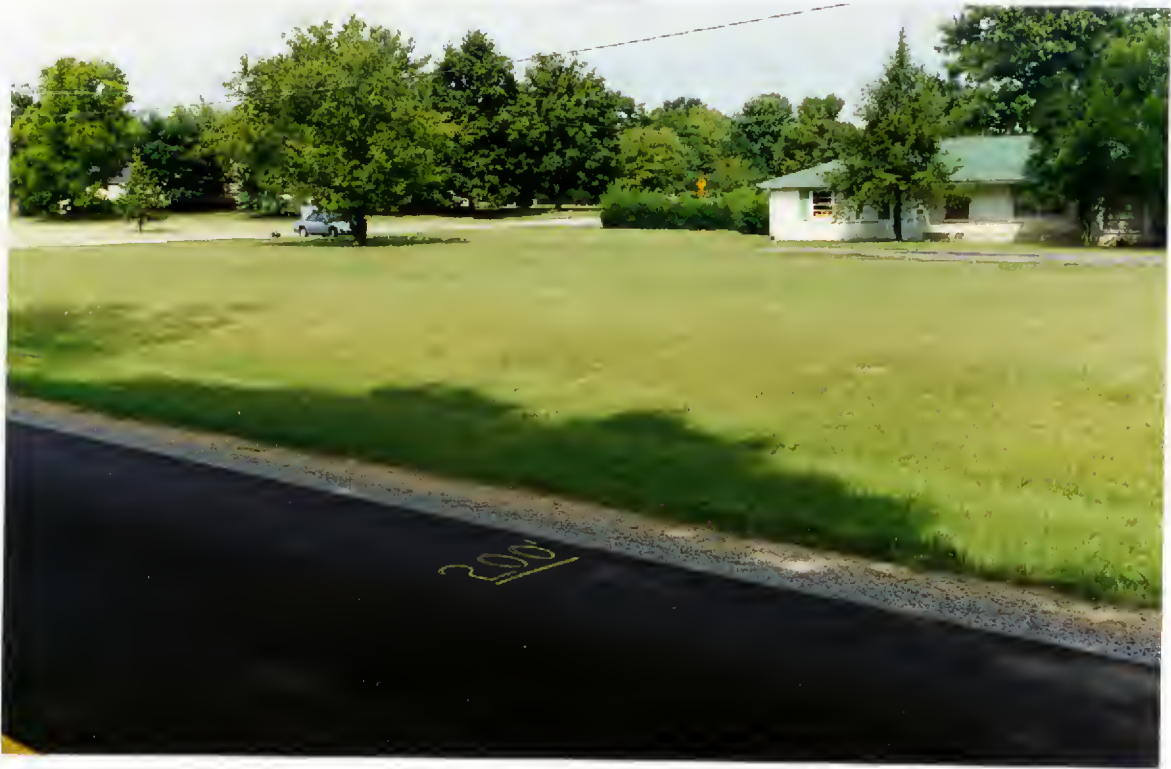
3. Dodge Caravan's view of Mercury Cougar's approach path at 61 meters (200 feet).

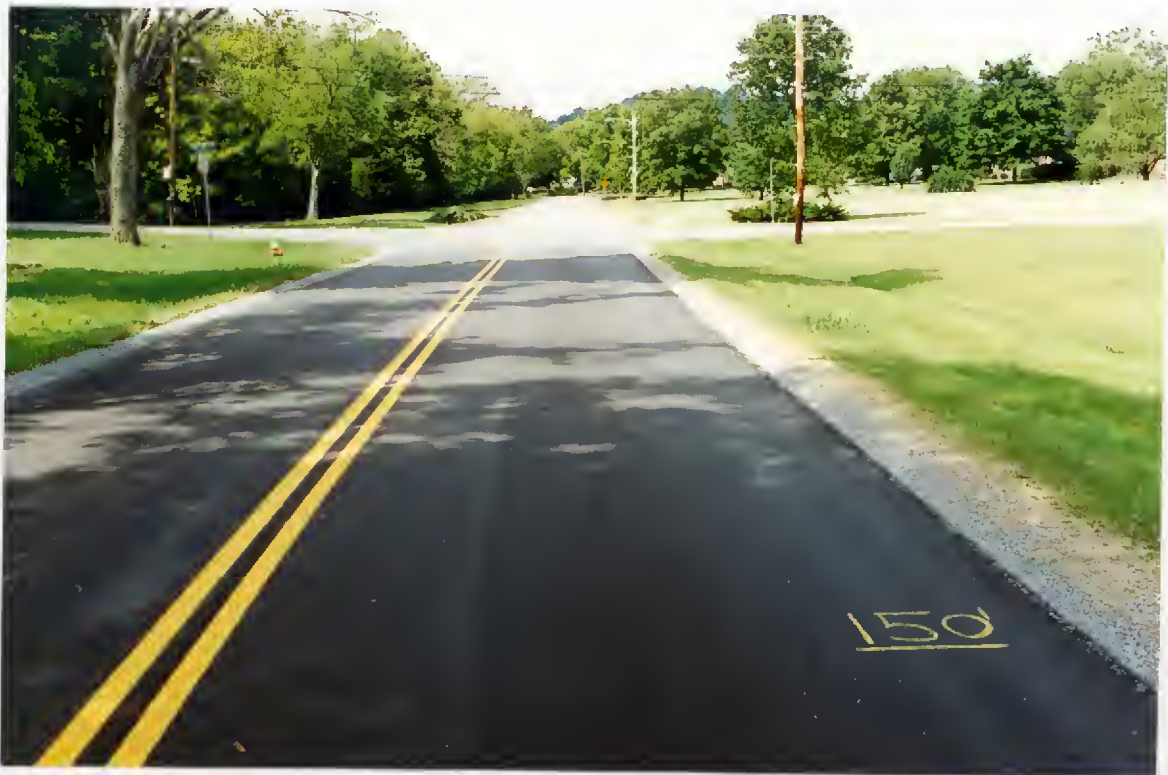
4. Dodge Caravan's approach view at 46 meters (150 feet) from the POI..

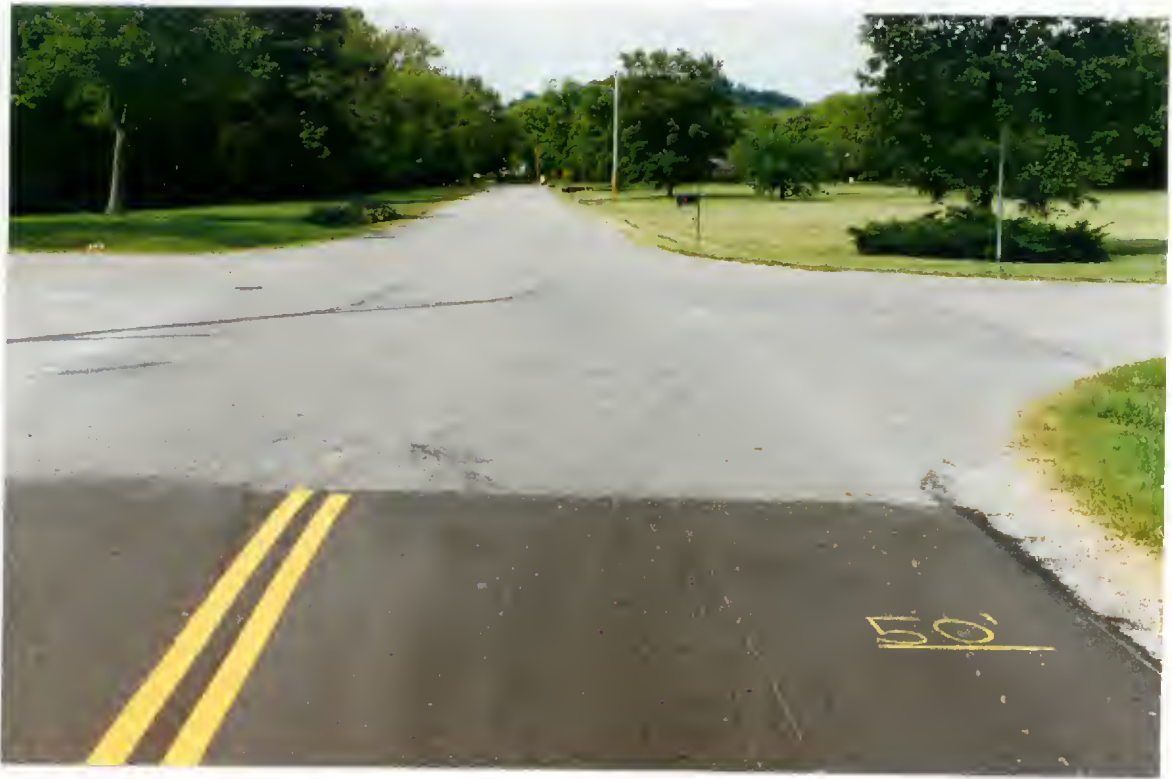
7. Dodge Caravan's approach view at 15 meters (50 feet) from crash impact point.

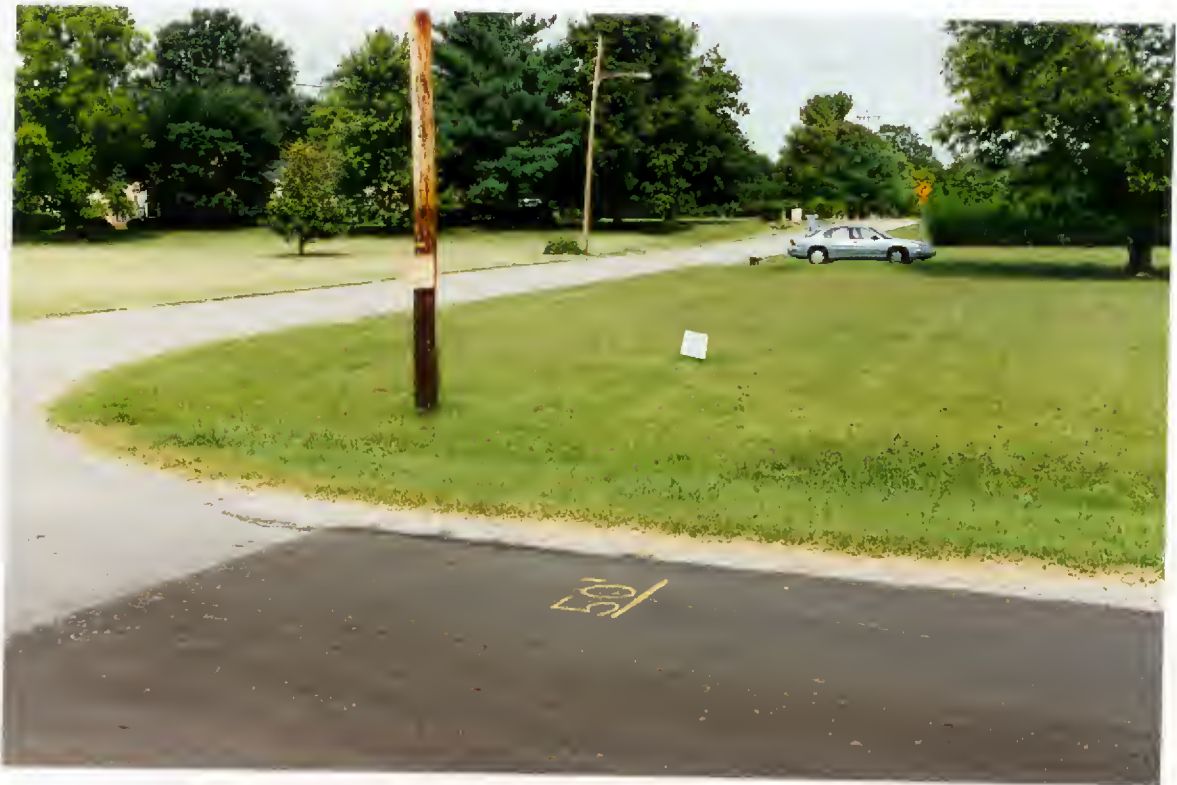
8. Dodge Caravan's view of Mercury Cougar's approach path at 15 meters (50 feet).

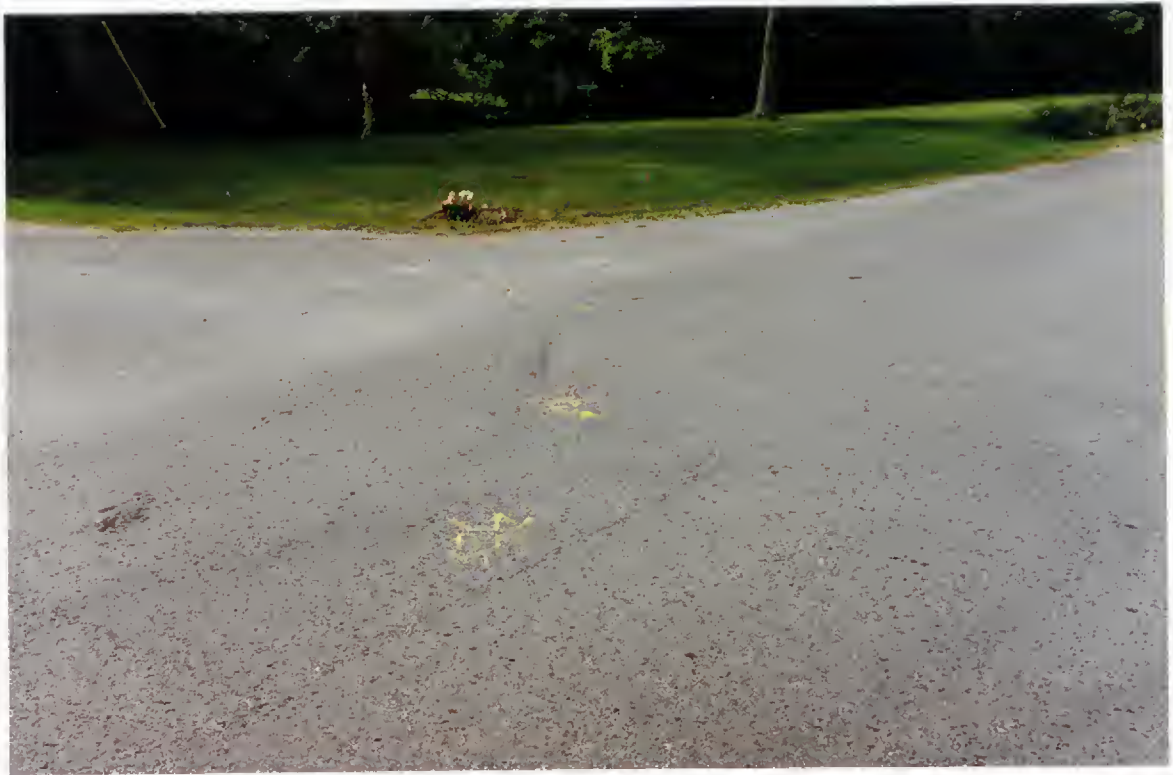
9. View of the POI.

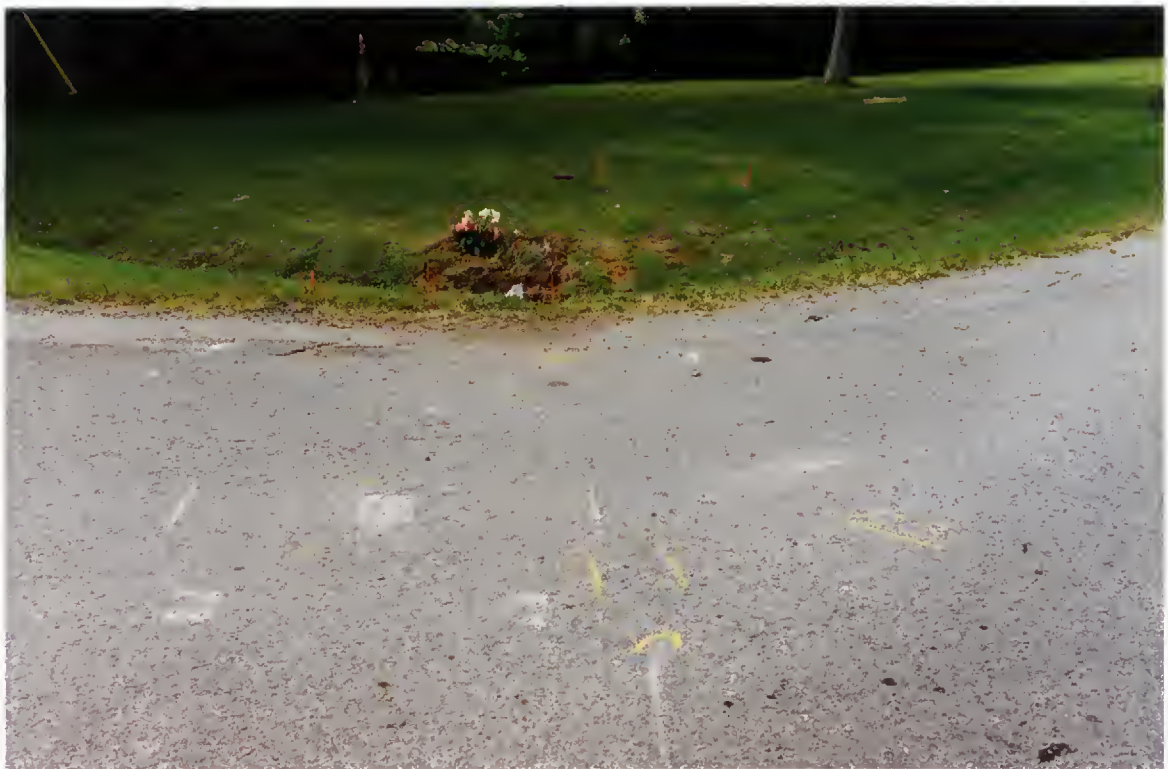
10. Post impact trajectory of the Dodge Caravan.

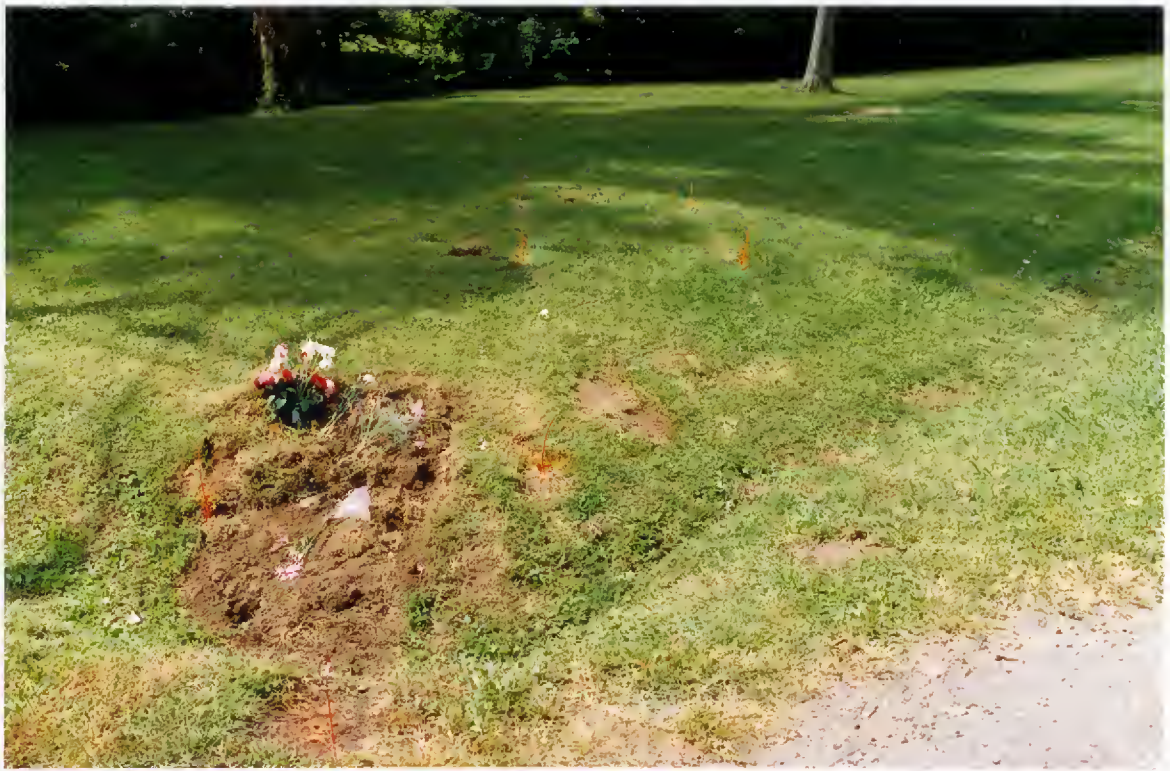
11. View of final rest position of Dodge Caravan and Mercury Cougar.

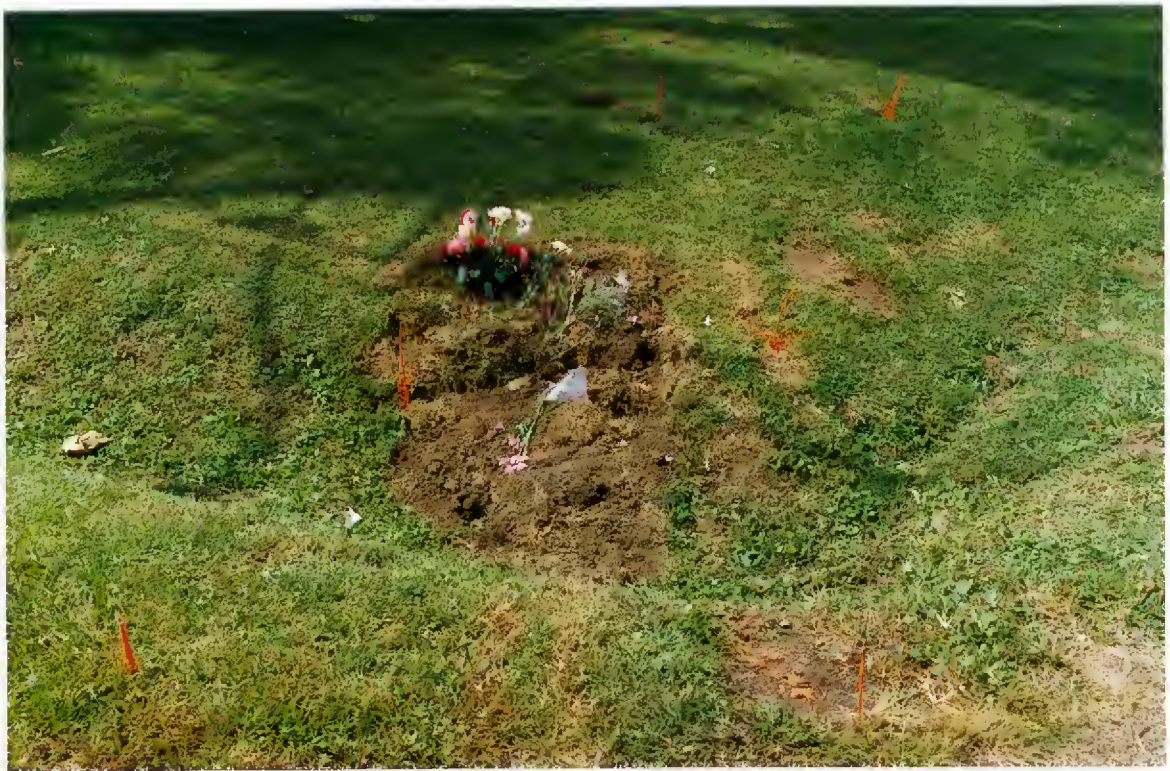
12. View of the embankment impacted by the front of the Dodge.

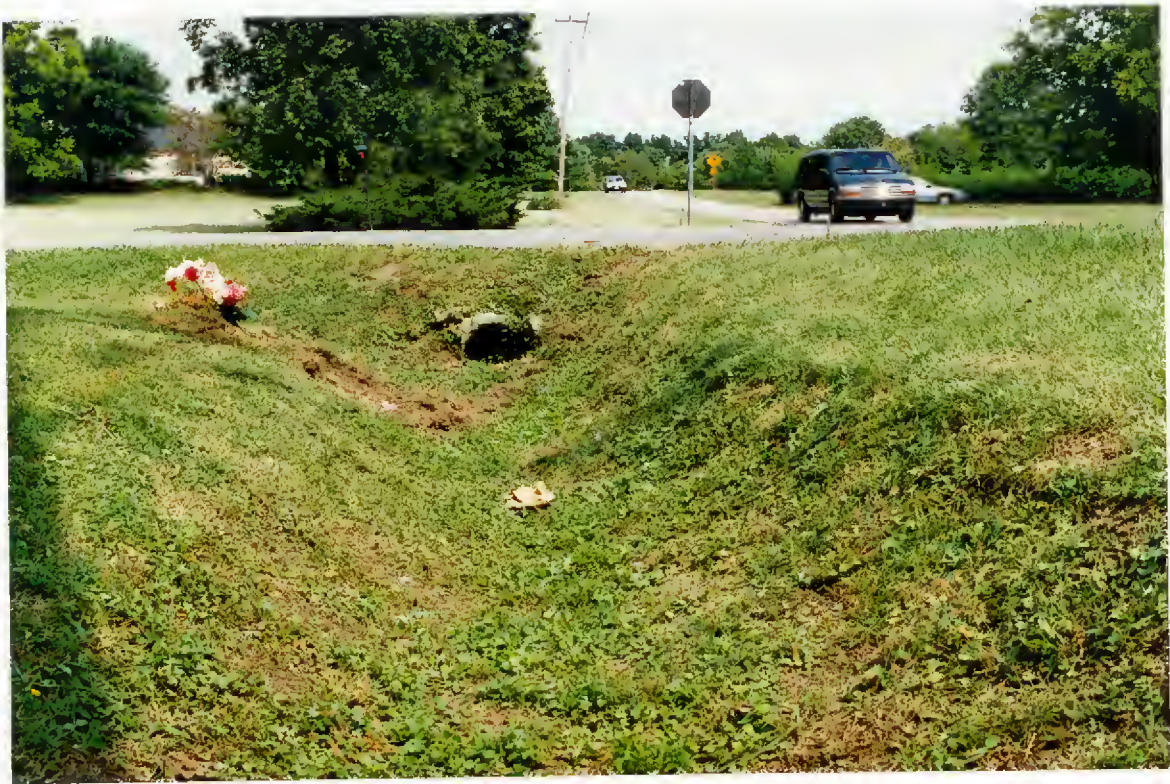
13. Westward view along the ditch line.

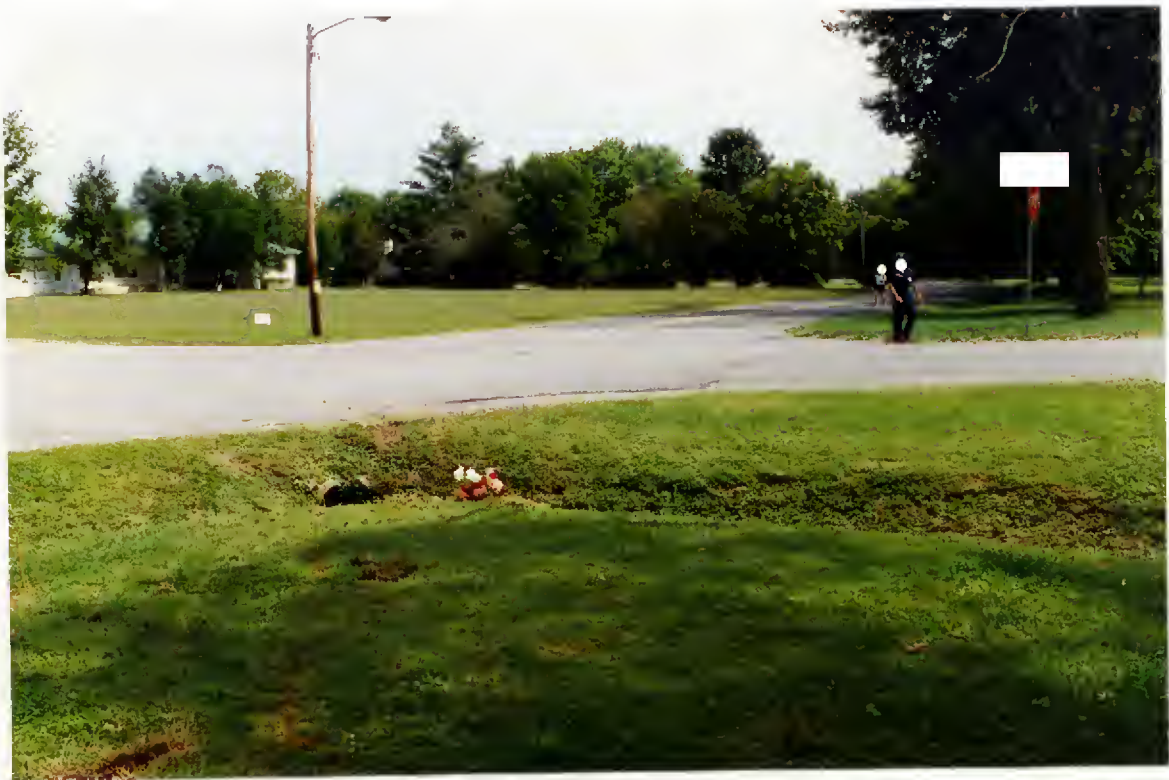
14. Look back view of from the Dodge Caravan's rest position.

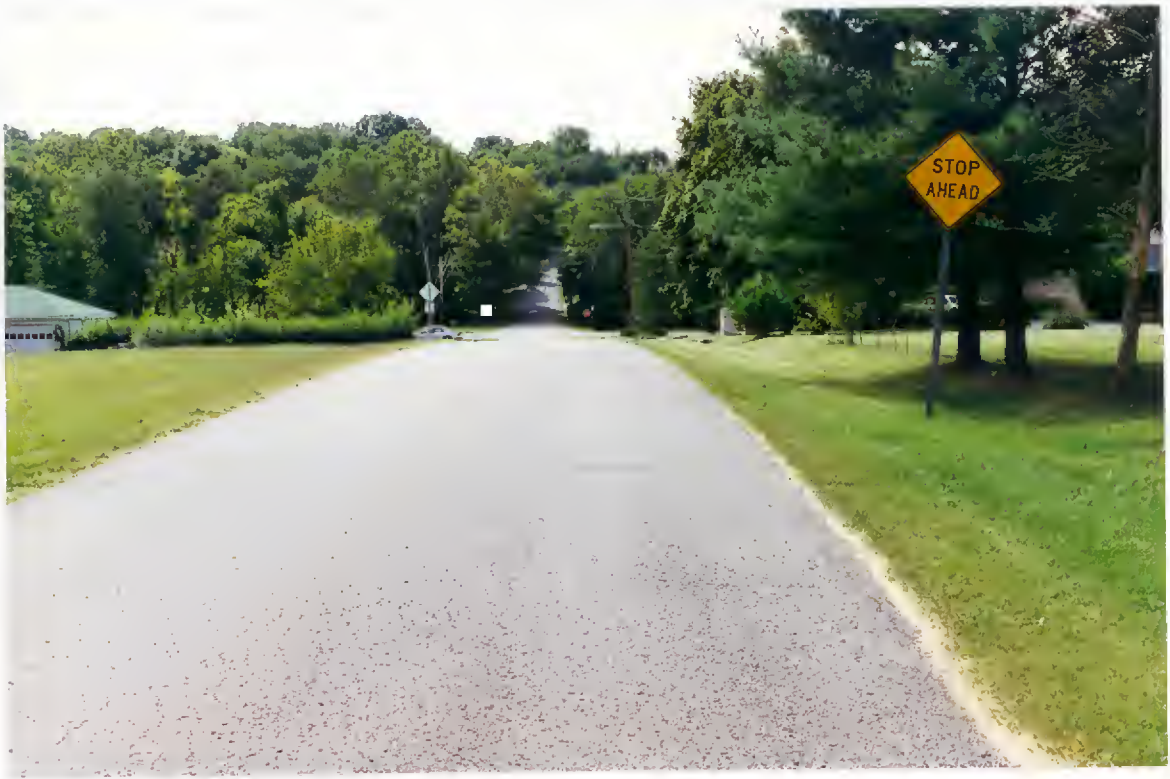
15. View of the Mercury Cougar's approach into the intersection at the hill crest.

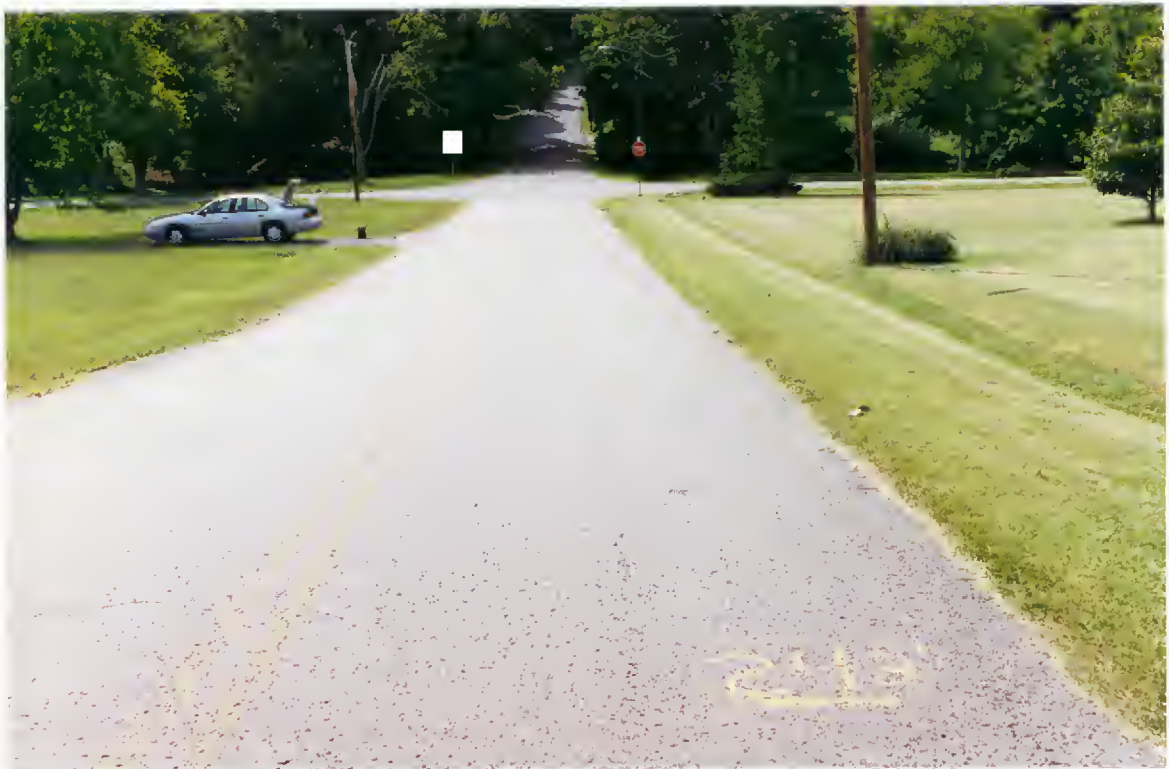
16. Mercury Cougar's approach view at 74 meters (243 feet) from the POI.

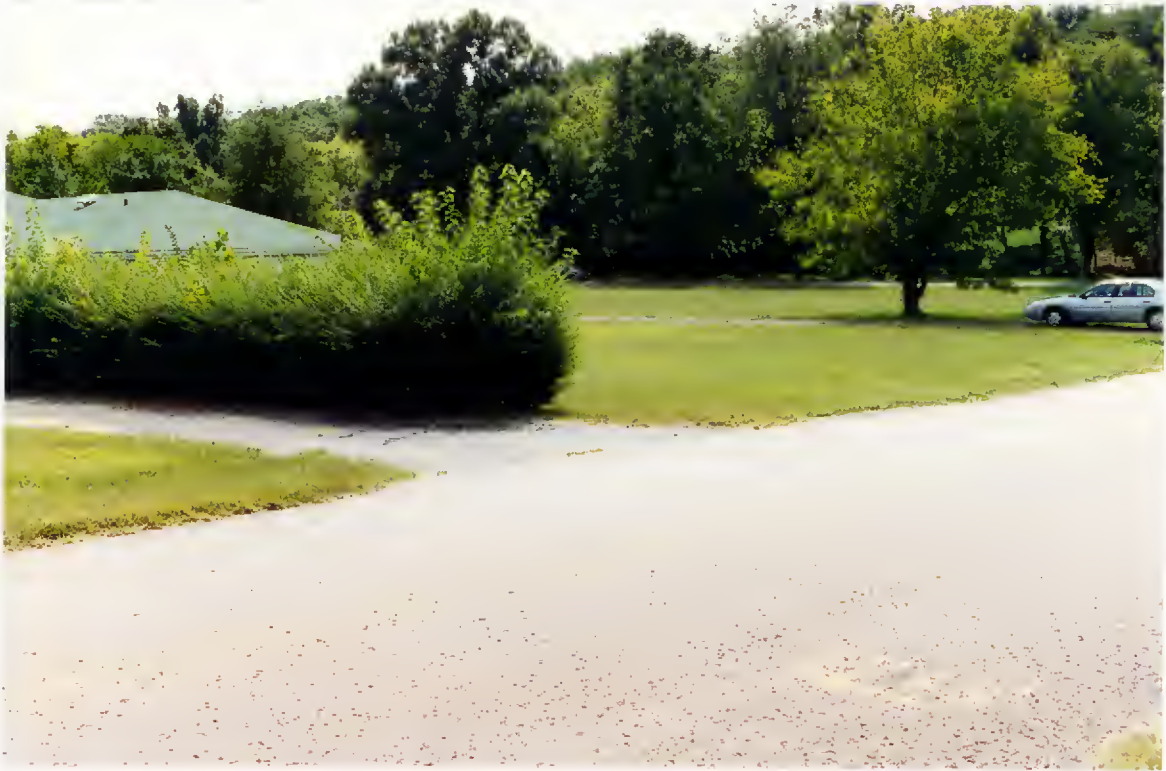
17. Mercury Cougar's view of Dodge Caravan's approach path at 74 meters (243 feet).

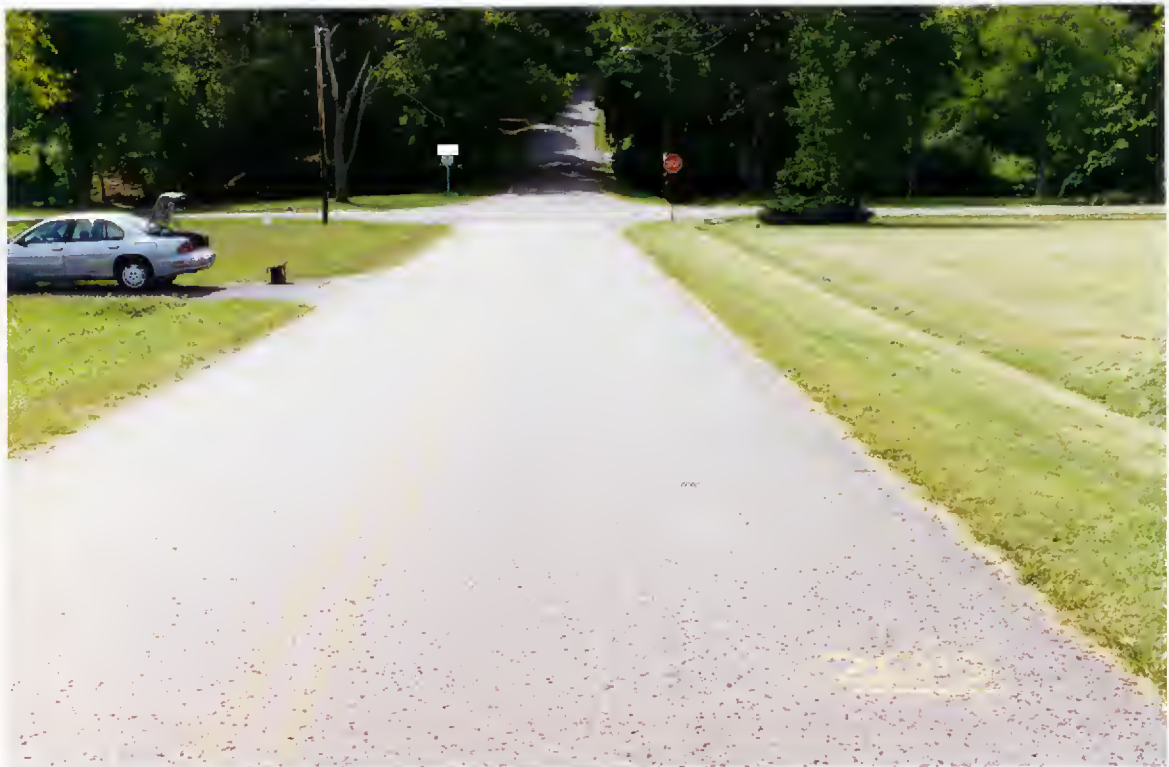
18. Mercury Cougar's approach view at 61 meters (200 feet) from the POI.

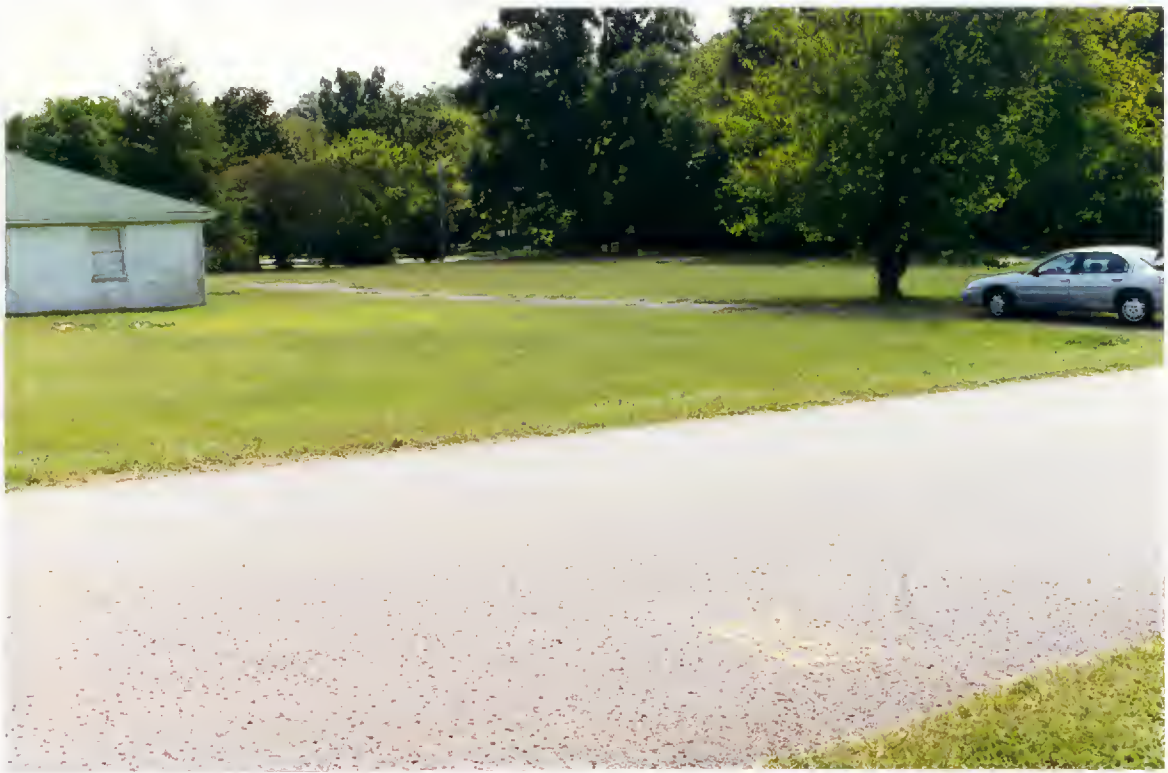
19. Mercury Cougar's view of Dodge Caravan's approach path at 61 meters (200 feet).

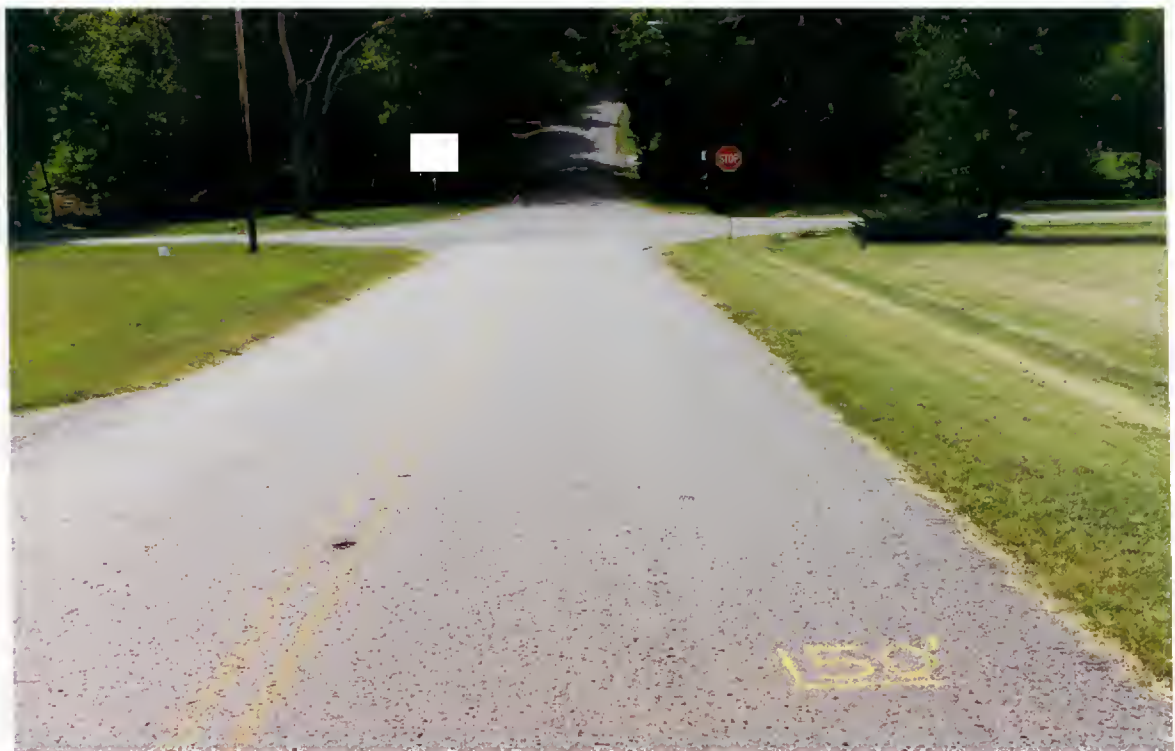
20. Mercury Cougar's approach view at 46 meters (150 feet) from the POI.

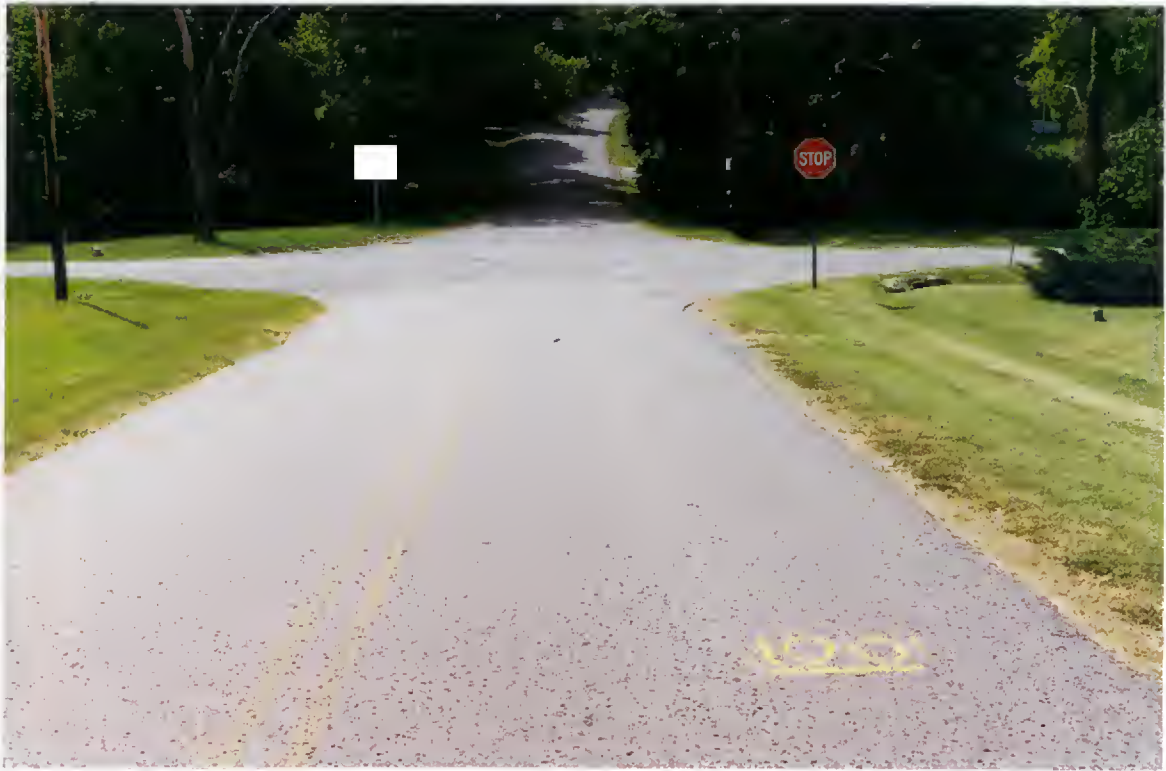
21. Mercury Cougar's approach view at 30 meters (100 feet) from the POI.

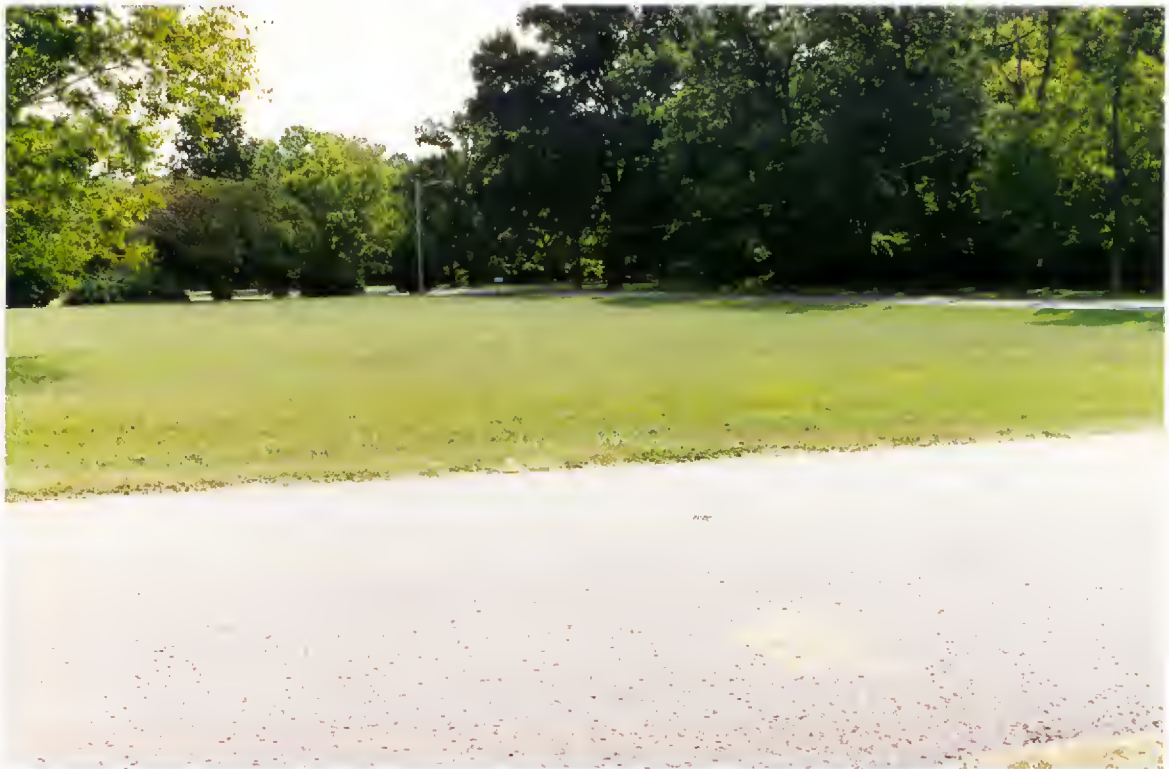
22. Mercury Cougar's view of Dodge Caravan's approach path at 30 meters (100 feet).

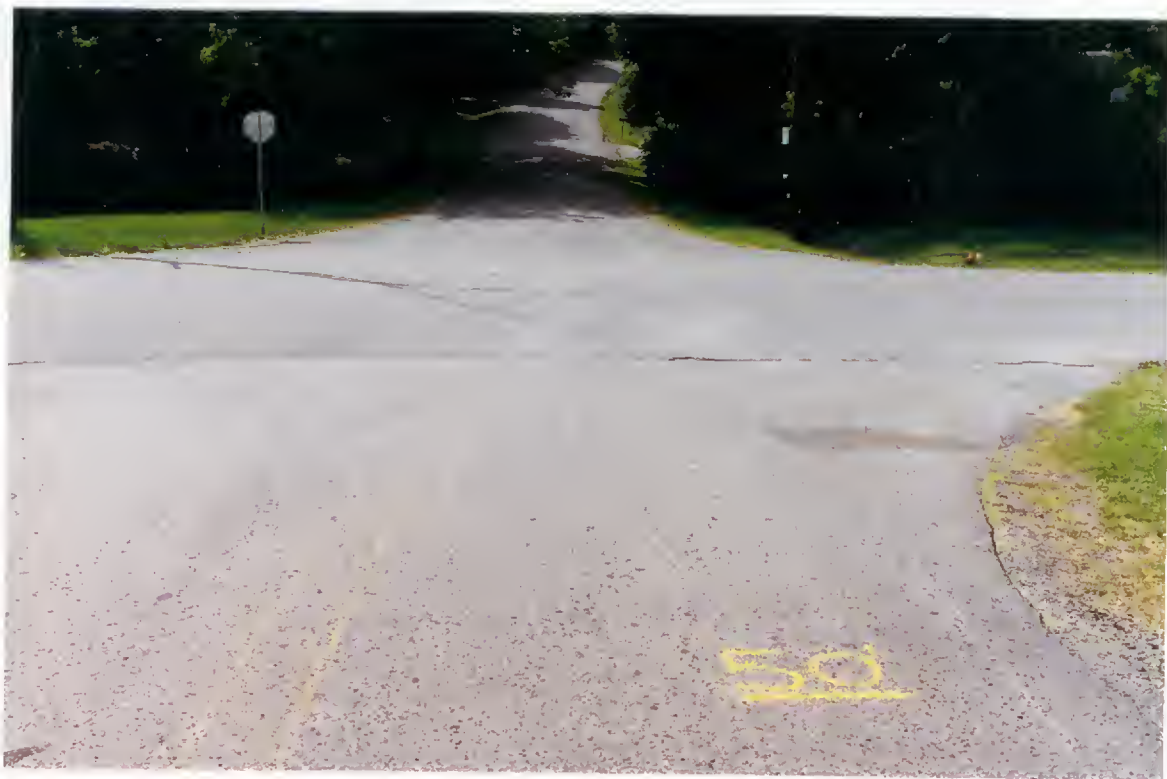
23. Mercury Cougar's approach view at 15 meters (50 feet) from the POI.

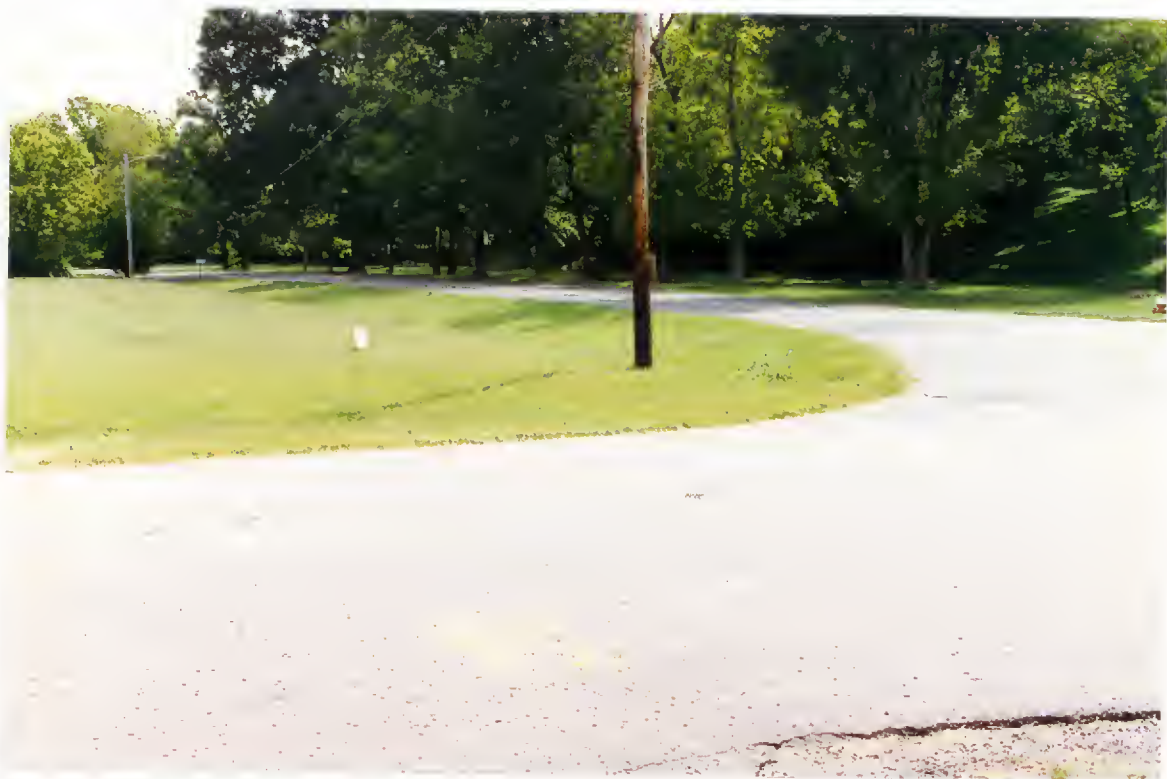
24. Mercury Cougar's view of Dodge Caravan's approach path at 15 meters (50 feet).

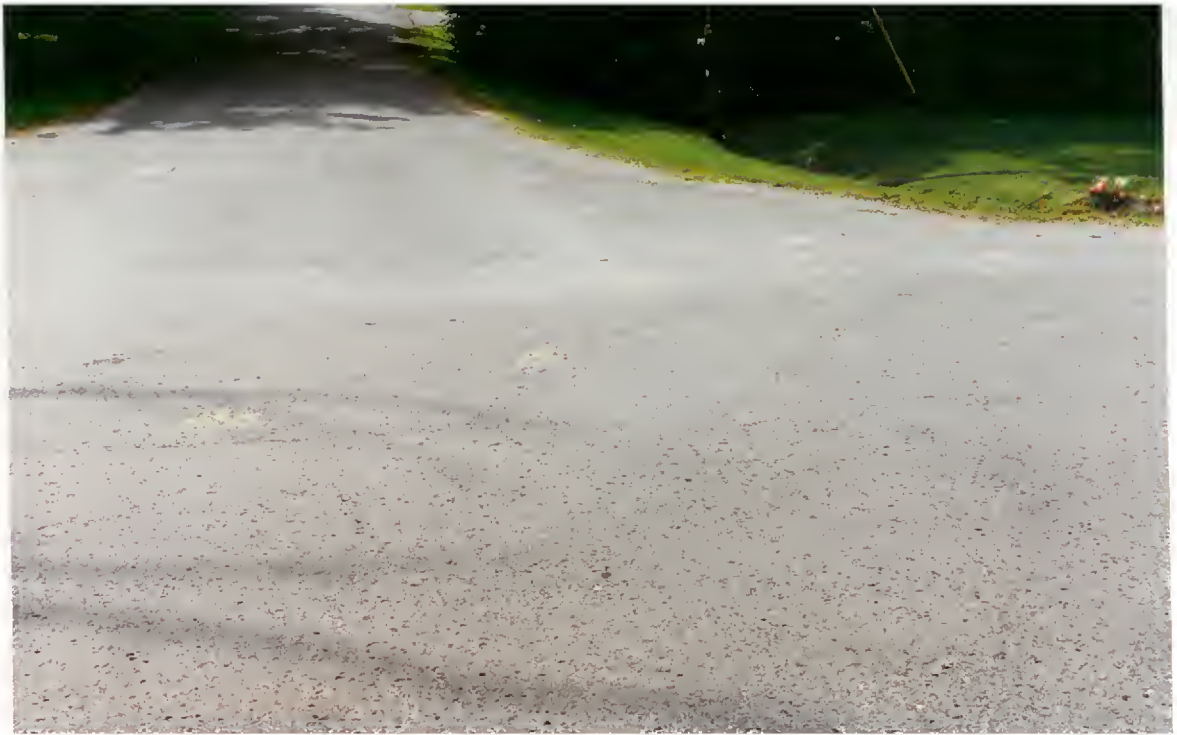
25. View of the POI.

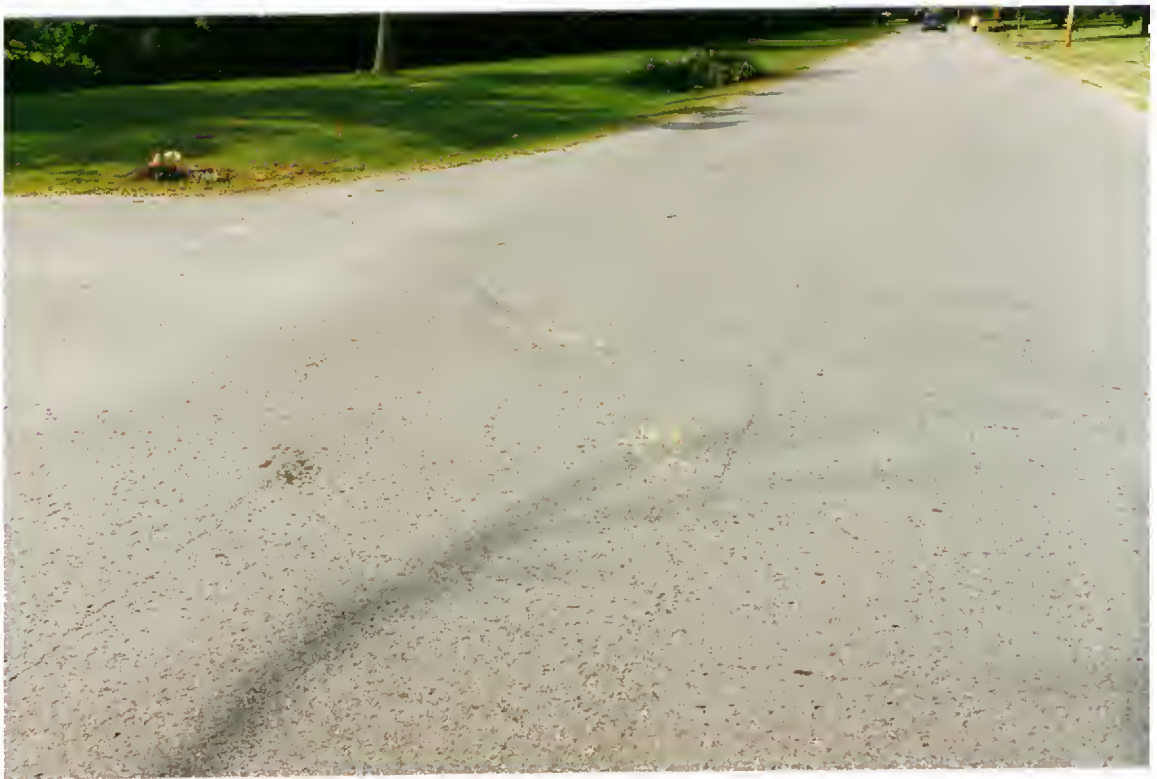
26. View of the post crash trajectory of the Mercury Cougar.

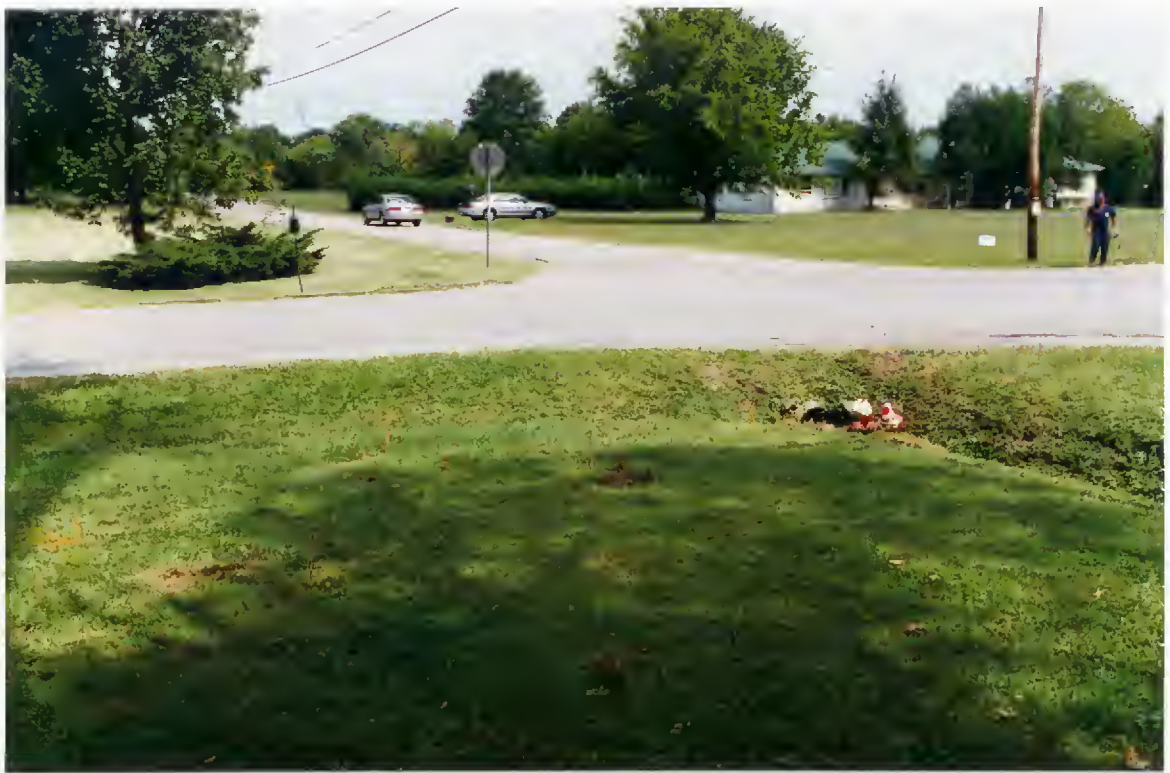
27. Look back view of the from the Mercury Cougar's rest position.
